PHOTOGRAPHIC LOG

Client Name: Delmarva Power & Light Co.		Site Location: Cambridge, MD	Project No. 01855-061
Photo No. 1	Date: 5/28/08

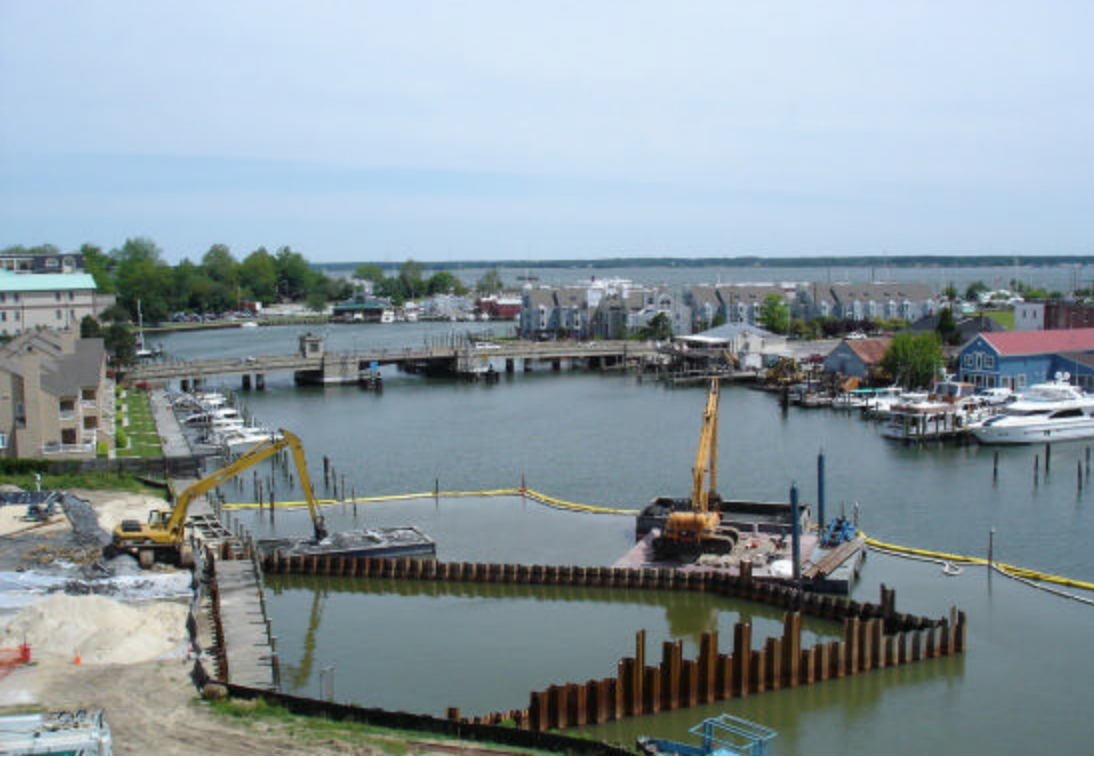
Direction Photo Taken: Aerial view looking north			
Description: Site overview showing temporary sheeting in water, perimeter controls, barge mounted excavator performing dredging, transport barges, and land based excavator used for load-out. (Phase 1)

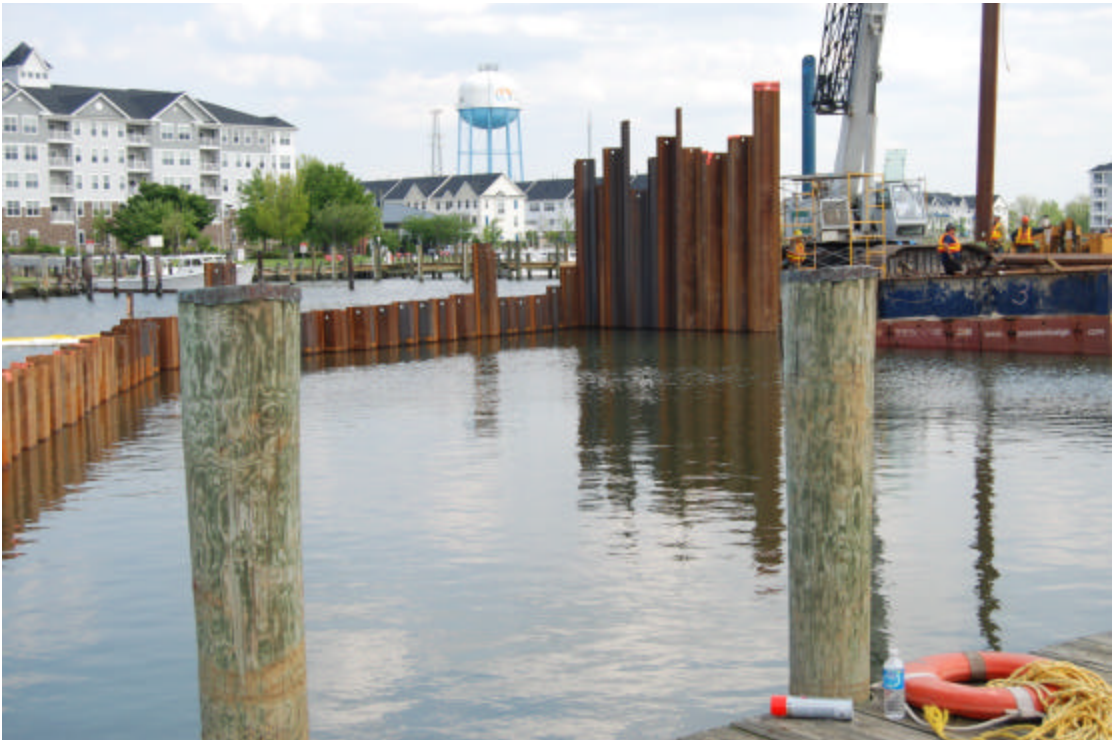
Direction Photo Taken: Looking southeast			
Description: Installation of temporary sheeting around NAPL area in Cambridge Creek. (Phase 1)

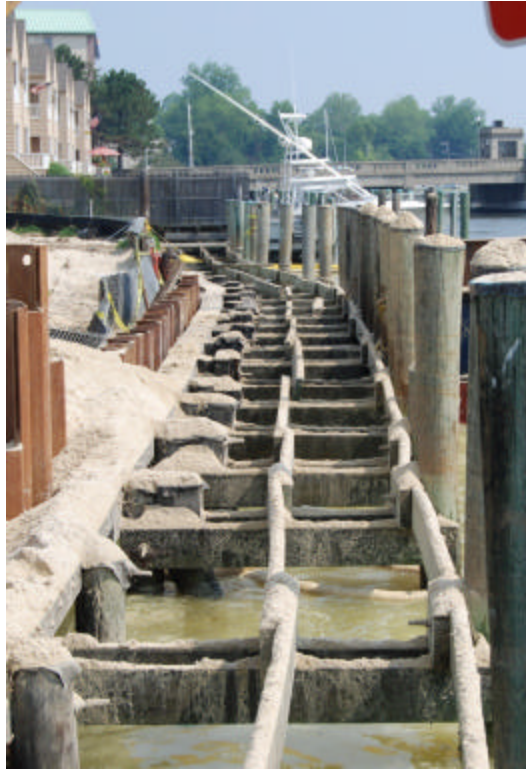
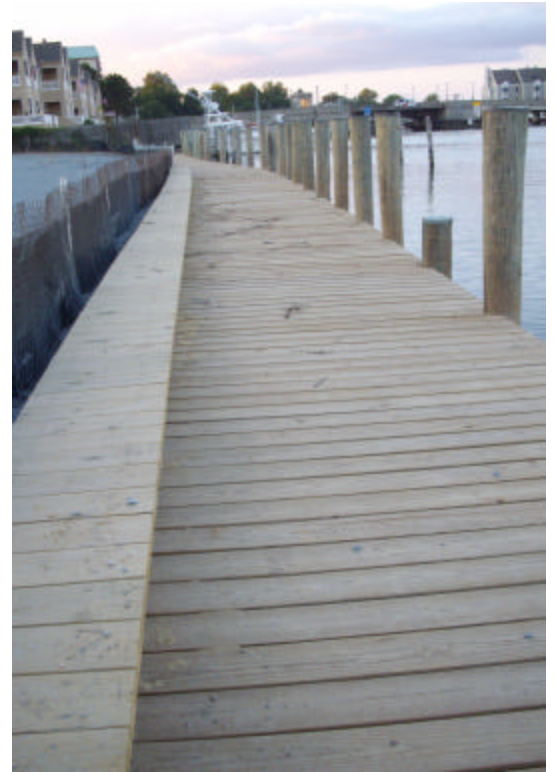
Photo No.
9

- 1) Dock replacement in progress. New replacement bulkhead on the landside of the dock.

- 2) Dock replaced.
Bulkhead capped.

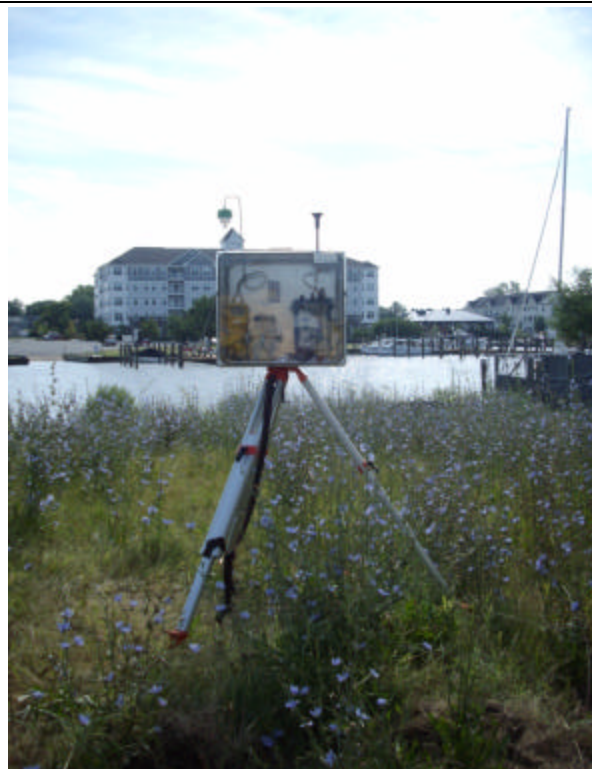
Photo No.
10

Air Monitoring Station #3
with PID and Particulate
Monitor.

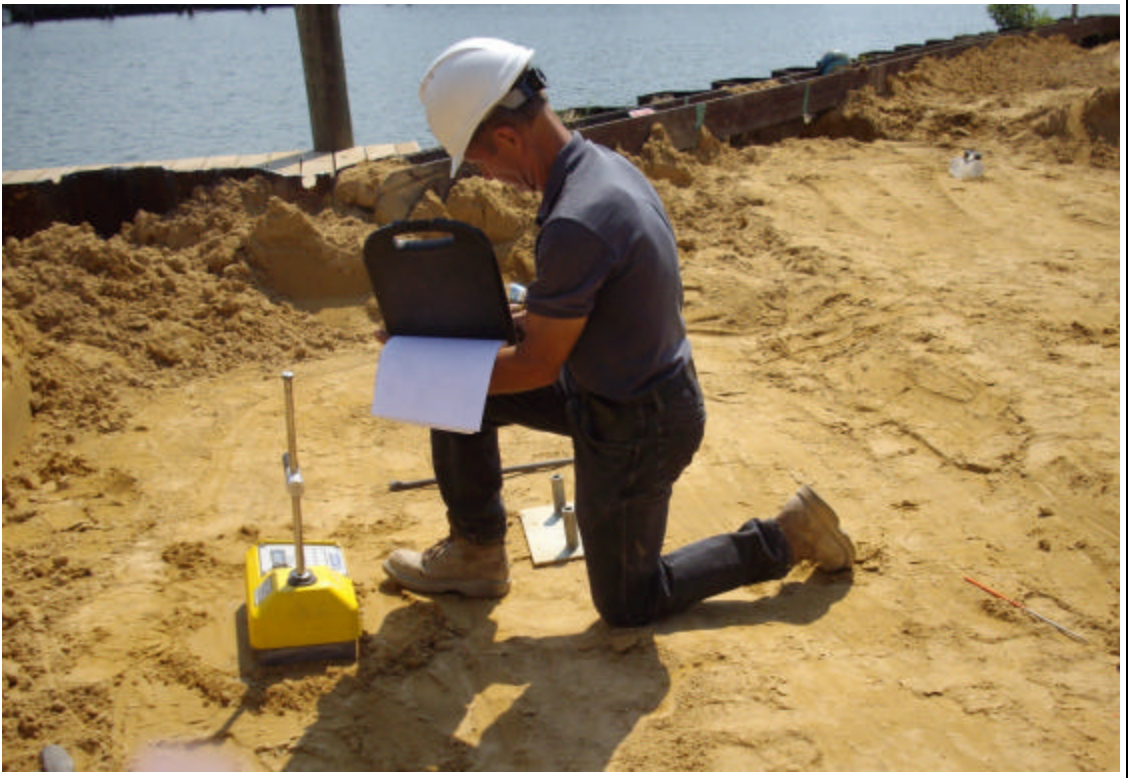
Direction Photo Taken: Looking east			
Description: Compaction testing by John D. Hynes & Associates (Phase 2)
